**TEARDOWN AND INSPECTION OF THE CUMMINS  
VTA-903 - EVALUATED USING THE SINGLE COMMON  
POWERTRAIN LUBRICANT (SCPL)**

**INTERIM REPORT  
TFLRF No. 450**

by  
**Adam C. Brandt  
Edwin A. Frame**

**December 2013**

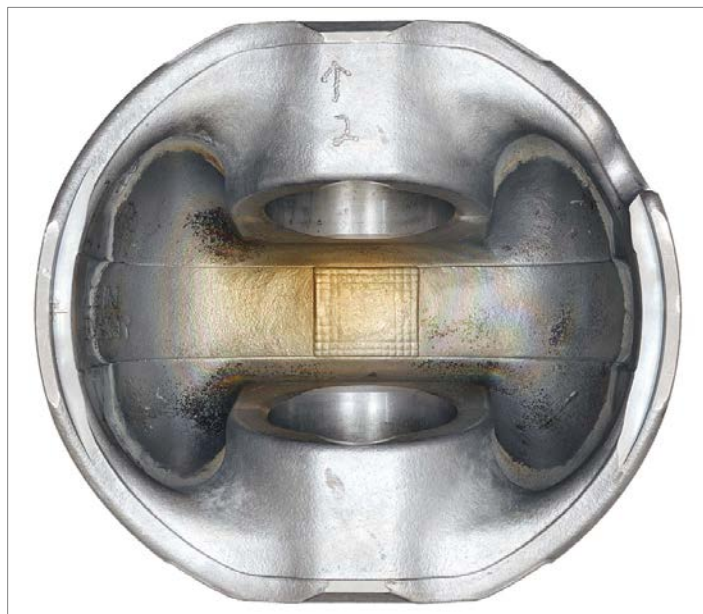
**Figure 29. Piston Undercrown, Cylinder #2**

Note, rust/water markings shown in the bowl of the number two piston looks to have occurred during the length of storage.
